## Needle Detection & Removal Manufacturing Process for Fabric Encased GCL Products

TN318 NeedleDetection R107/15/10

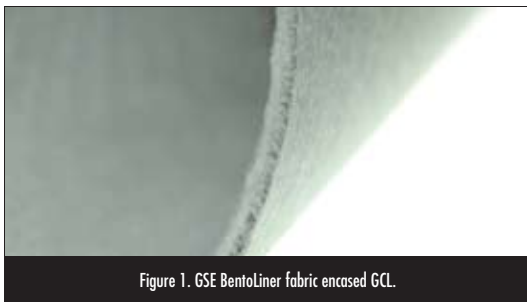
Figure 1. GSE BentoLiner fabric encased GCL.

GSE BentoLiner fabric encased geosynthetic clay liners (GCLs) transmit internal shear stresses from the upper geotextile to the lower geotextile by needlepunching the fibers from the nonwoven cap geotextile, through the bentonite layer, and lodge the polypropylene fibers into the lower carrier woven or nonwoven geotextile. This forms a composite GCL consisting of geotextiles which encapsulate, support, and provide internal shear strength to the low permeability bentonite layer (Figure 1). The geotextiles utilized in the production of all GSE BentoLiner materials are specially formulated polypropylene woven and nonwoven geotextiles manufactured to specification specifically for GSE BentoLiner GCL materials.

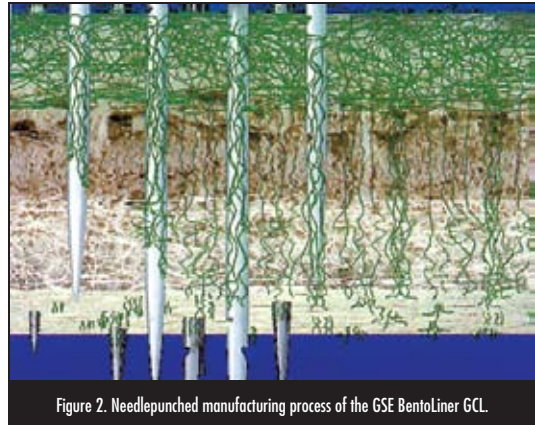
Figure 2. Needle punched manufacturing process of the GSE BentoLiner GCL.

The 4 in (100 mm) long needles used in the needle punching process for GSE BentoLiner reinforced GCLs, consist of steel needles with spaced barbs, which grab fibers from the upper nonwoven geotextile, and pull the fibers through the bentonite and the lower woven or nonwoven geotextile (Figure 2). This transforms the random fiber arrangement of fibers in the upper polypropylene nonwoven geotextile into a 3-dimensional structure by the up and down moving needle boards during conveyance of the GCL material through a needlepunching loom. These looms punch the barbed needles, containing up to 13,800 needles/meter width, at up and down speeds rang-

ing up to 1200 strokes/min (Koerner & Koerner, 2002). This is similar to the needlepunched process by which nonwoven geotextiles are manufactured and has been commonly used in the textile industry in the U.S. since the 1950's.
